Slip Resistant Steel Stair Treads Installed at Warehouse Door for Art Van Furniture

SlipNOT® Project Summary

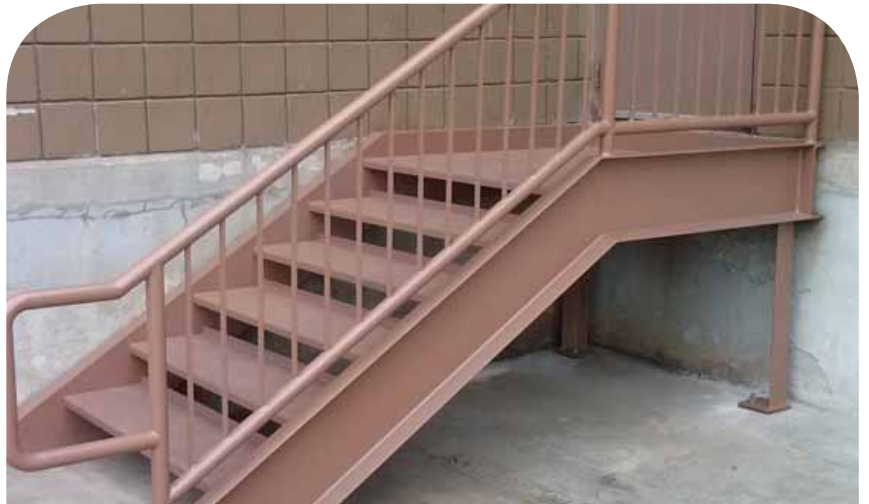
- 1/4" x 50 1/2" x 48" treads and 1/4" x 12 1/4" x 48" treads with 1 1/2" nosings and risers
- **SlipNOT®** provided non slip steel plate stair treads for Art Van's exterior warehouse stairway.

The steel fabricator contacted **SlipNOT®**'s sales department to provide a quote for steel plate stair treads. They provided a drawing showing $\frac{1}{4}$ " stair treads were needed; one piece measuring 50 $\frac{1}{2}$ " x 48" and five pieces 12 $\frac{1}{4}$ " x 48" with 1 $\frac{1}{2}$ " nosings and 1 $\frac{1}{2}$ " risers. By providing a drawing of the treads, Art Van Furniture can be assured that the treads could be installed with ease and needed no further fabrication in the field.

Since the application was located outdoors, the stair treads were painted to help protect against snow, water, ice and other types of moisture found in the Michigan climate. Steel plates in wet environments must be galvanized or painted to help prevent rust and corrosion. The slip resistant surface also ensured that employees transitioning from the warehouse floor to the outdoors will not slip and fall from oils, water and other lubricants found both outside and inside the warehouse.
